Atlantic Shore Railway
Locomotive 100
Curatorial Report no. 10
14 January – 2 February 2008

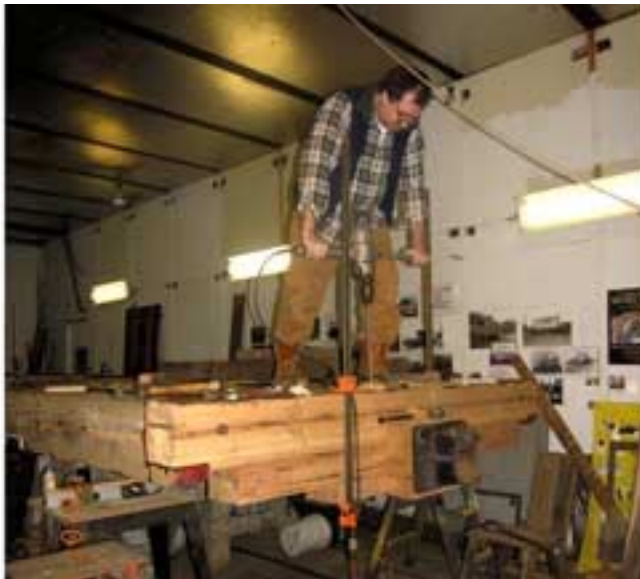
Randy was the 'heavy' in the drilling 'department'. We used a very big old Craftsman drill which had no trouble turning the 13/16 in. drill. However, despite its age (at least 100 years), the SYP was full of sap. This tended to make the chips from the drill stick to it and plug up the hole. In fact, on several holes we had to run the drill all the way through; then 'unchuck' the drill and remove it from the bottom. The holes were still filled with jammed chips so they had to be forcibly driven out with punches and re-drilling. We discovered that spraying "P.B. Blaster"⁴ on the drill was quite helpful. Several people including Dean Look & Bob Reich commented on the scent of pine that wafted out of the box during this operation!

Randy Leclair using the big drill to make holes for bolts to fasten sill assembly together.

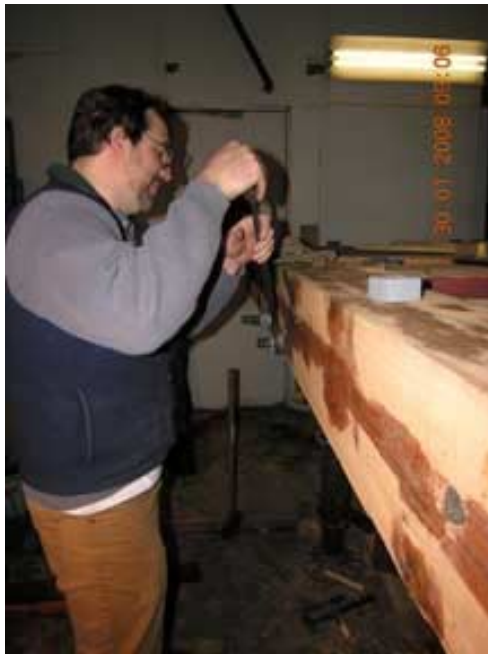
Randy tightening bolts on no. 2 end.

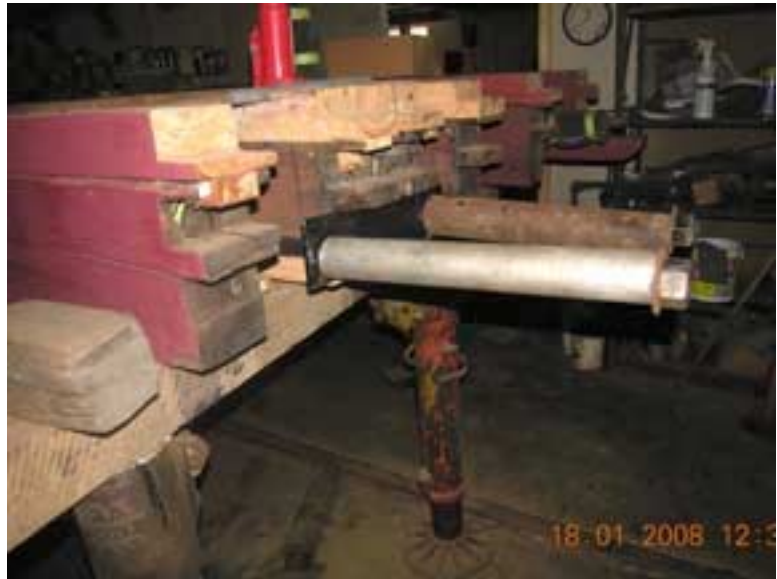
The giant clamp - The next morning we devised a giant clamping system to get the sill on the rest of the way. There are four 1 ¼ in. round rods running from end to end of the car and out through each end sill. The ones on the corners are bent down in the center of the car and come out at each corner through the pole pocket casting. In the center are two others (between sills 3 and 4 and 5 and 6). These are straight from one end of the car to the other and serve as the major anchors that hold the couplers and take the strain when 100 pulls a freight car. Because the side rods are bent somewhat U-shaped, it was impossible to have them exert any tension at this point.⁵ However the straight ones can be used to create lots of tension. On the no. 1 end, they are passed through the two 1 ⅝ holes drilled through the sill about 2 in. above the bottom. Then large flat washers and heavy hex nuts are put on and the rods pushed right against the sill. On the no. 2 end, a large plate with two holes was put over the two rods; then pipe spacers are put over the rods followed by nuts and washers. Now when the nuts are tightened, they will exert tremendous force on the sill forcing it to pull up tight into place, which they did very nicely.

The anchors on the no. 1 end, 31 feet away.

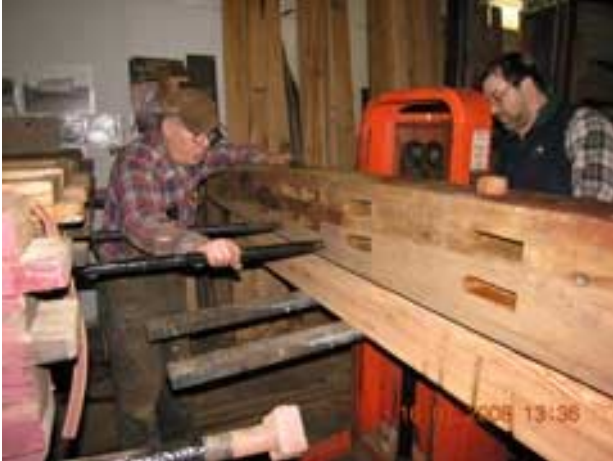
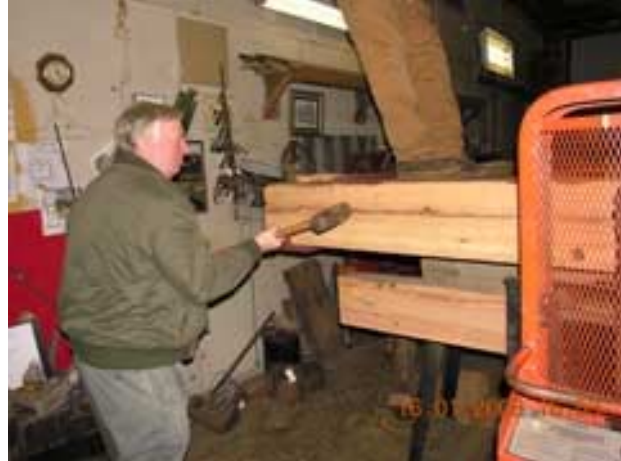
Donald Curry & Randy Leclair lining up the through-bolts to go through the end sill.
Norman Down giving a little help to getting it in place.

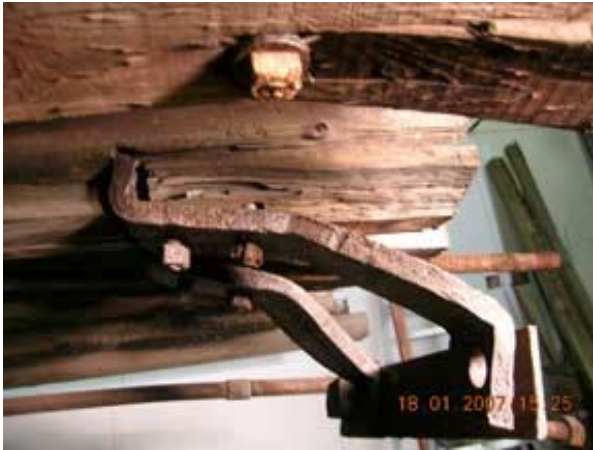
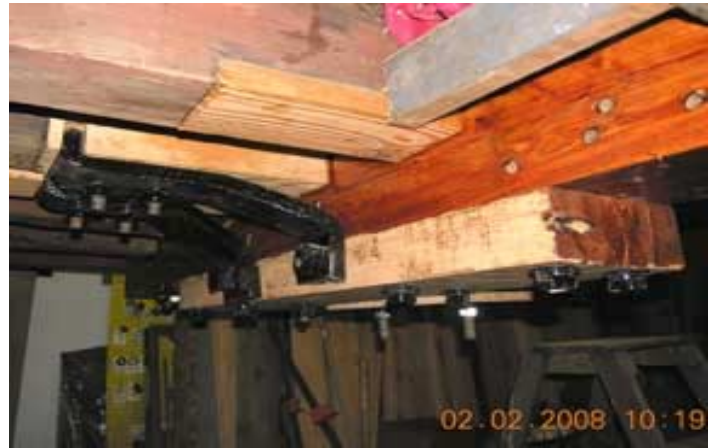
The couplers – are held on by the two center through rods and two 1 ¼ x 17 in. home-made square-heads under the sills and projecting out through the bottom layer of the end 'sandwich'. They hold a pair of Laconia-forged brackets which, after sandblasting, turned out to be in perfect condition. It is interesting to follow the grain of the metal in them and in the bolts indicating how they have been forged. The heads of the bolts are nuts held on by peining over the end of the rod. The coupler mount is spaced out from the end sill, thus clearing the pilot, by a pair of 6 x 6 in. (approx) x 16 ¼ in. blocks, also held by the same bolts. There is also a pair of vertical bolts holding the two together. To these bolts attach heavy steel straps (about 2 x ½ in.) which appear to be some sort of brace for the coupler.⁸ Both of these were quite badly before we started on the project. Very likely they caught on the ties as they hung so low, which caused them to be bent back on themselves.

This morning we installed the first set of coupler mounting brackets under the no. 1 end. Then the long bolts were pushed out through them and the wood coupler mounting blocks. When we went to put the actual coupler mount on we discovered it wouldn't fit. The spacing on the two bolts and two rods, which should have formed a rectangle, didn't. We used a small (4-ton) hydraulic jack between the top rod and bottom bolt to push the bolt down, which it did but not quite enough, so we will very likely have to heat up one or both bolts to get bend them slightly.

Coupler mounting brackets before and after

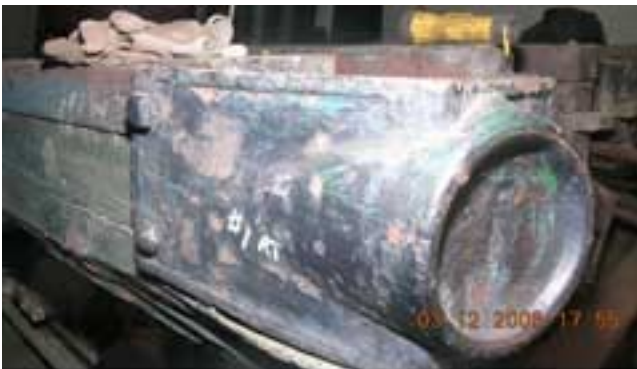
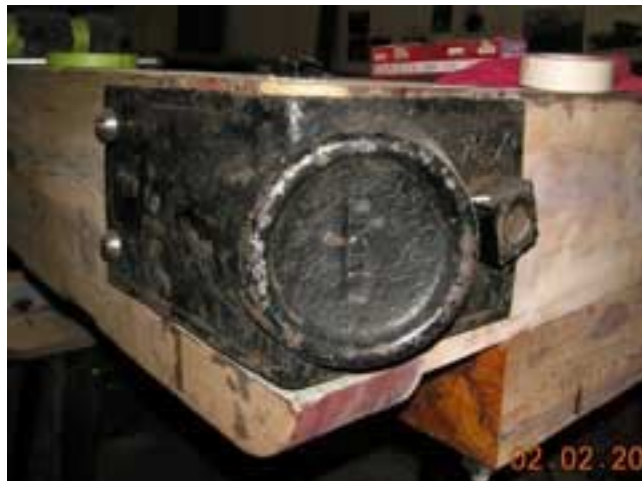
Poling pockets – On each corner is the poling pocket, used for pushing a car on an adjacent track to the one on which the locomotive ran. They are made of malleable iron or cast steel and have become slightly bent over the years. Dean straightened them out and welded in a patch where a chunk was missing. (Try and find which one it is!) The front surface has the hole for the truss rod and the side surface has holes for two special round-head bolts. We would not have known this detail except fortunately one rather rusted original one remained.⁹ Dean fabricated new bolts with the special high round head by taking a $\frac{3}{4}$ x 6 $\frac{1}{2}$ in. square-head bolt, turning it round and then adding weld to give it enough material to turn to the proper shape in the lathe. For that he ground a special rounding-over tool.

Poling pocket before and after. (Still to be blasted and painted)

The original bolt was not quite a carriage bolt in that it did not have the square under the head to keep it turning in the wood. To do this, Dean welded on a small lump so, when the bolt is driven into the hole in the wood it won't turn.

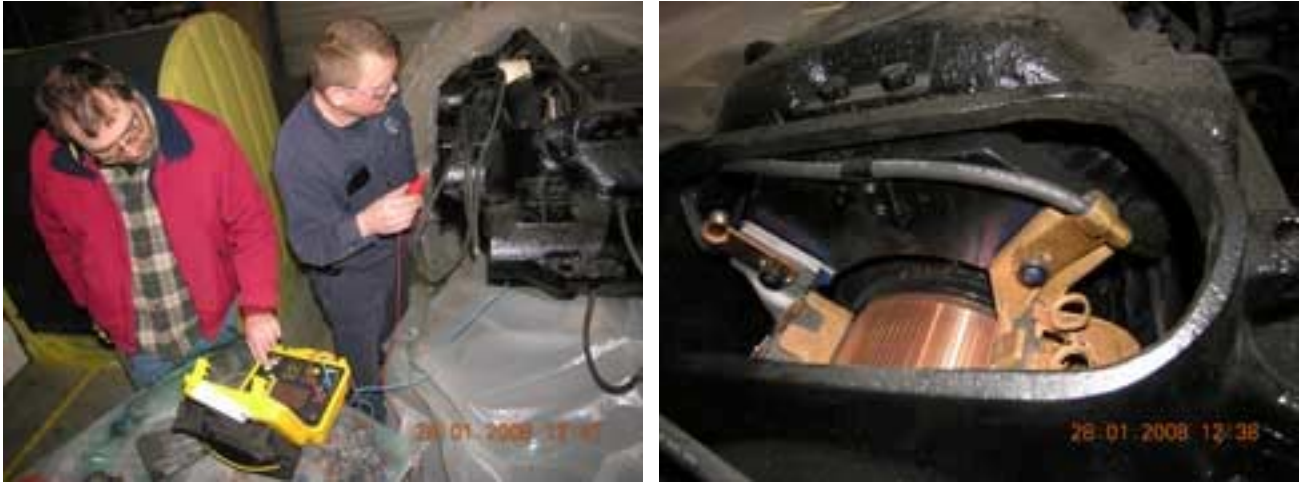
likely remain there for another year until the second truck is done. Using our new AEMC 1060 megohmmeter¹² we tested the insulation and came out with an amazing 2.5 gigohms! That's 2,500 megohms or 2,500,000,000 ohms! (Have I got the right number of zeros?) We were rather pleased that it would measure that closely.

Randy Leclair monitoring the new AEMC 1060 megohmmeter while Roger Paradie makes the connection to the overhauled GE 80 motor at A. C. Electric
