Atlantic Shore Railway
Locomotive 100
Curatorial Report no. 10
14 January – 2 February 2008

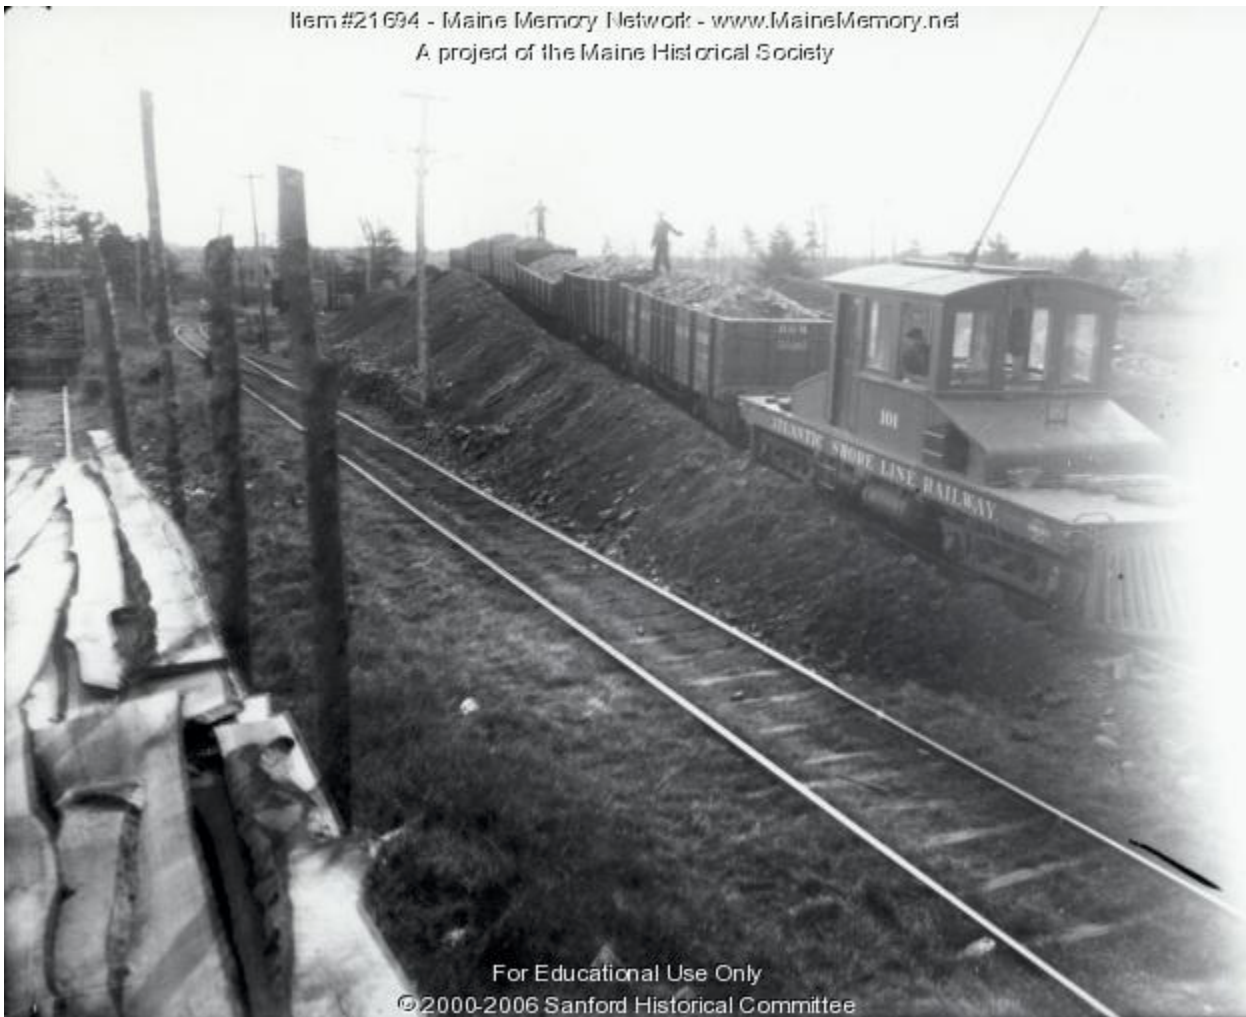
If you look very closely you will see this is actually 100's sister locomotive, no. 101. That makes this photo even rarer for two reasons. First it shows the coal hauling operation in progress and secondly it shows 101 in its extremely short lifetime as a steeple cab. (Nov. 1906 until some time in mid 1908, when it became an express car, giving up its cab to 102.)
